TESTS OF A LIGHTWEIGHT 200 KW MHD CHANNEL AND DIFFUSER

TECHNICAL REPORT AFWAL-TR-80-2021

Final Report for Period March 1977 through December 1978

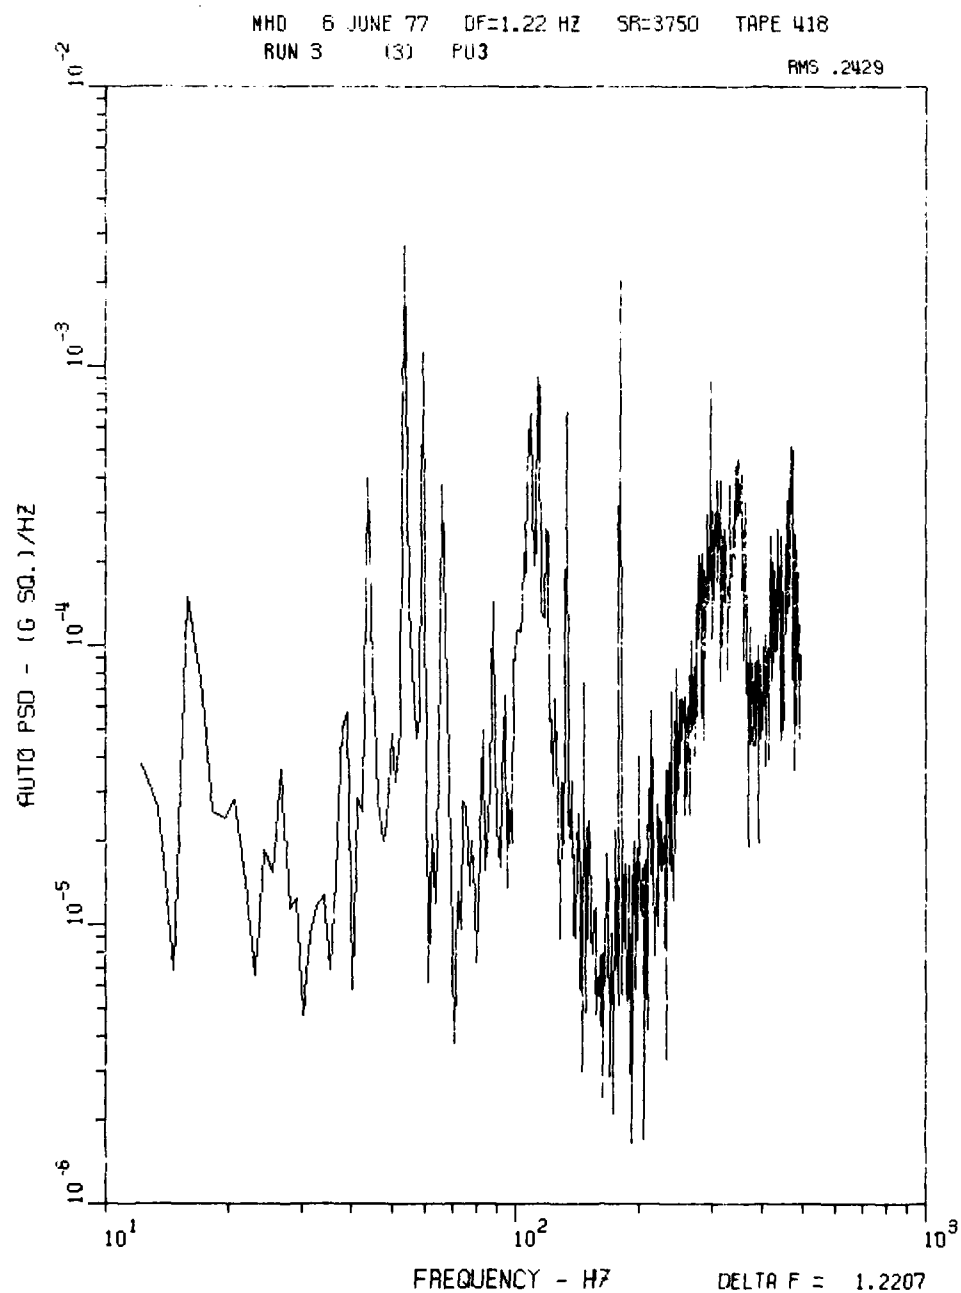
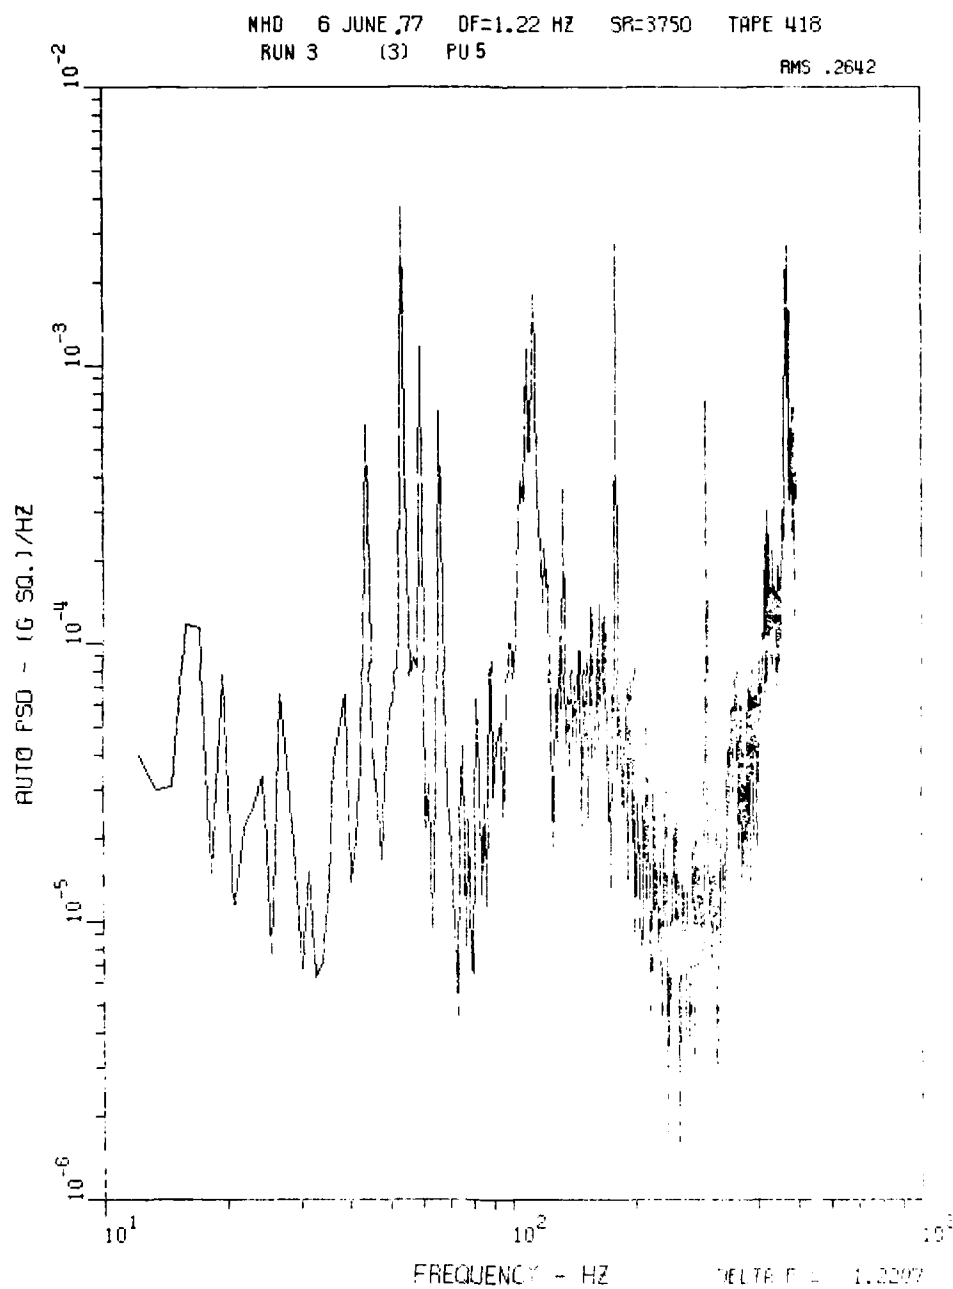
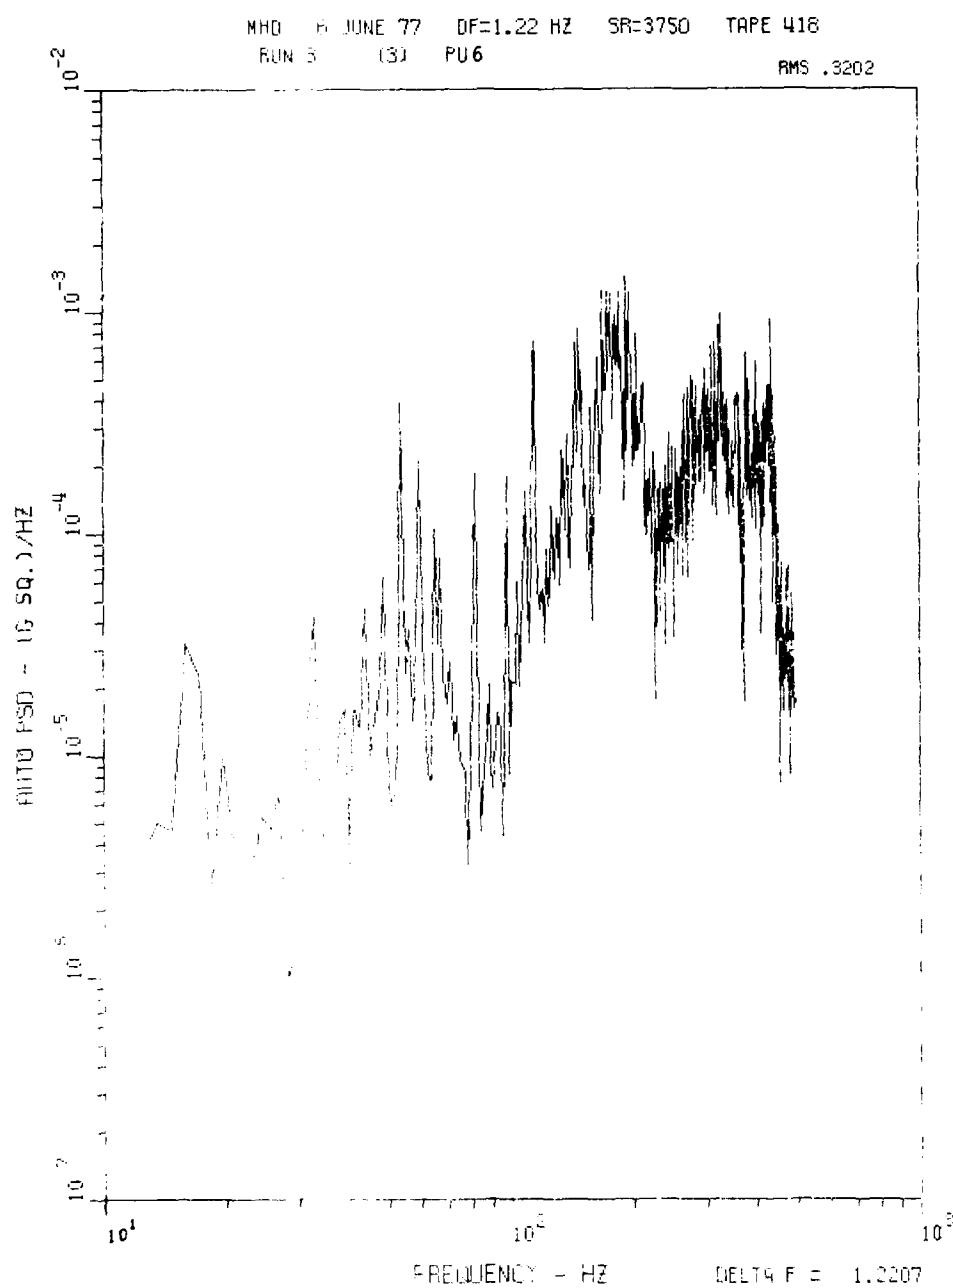
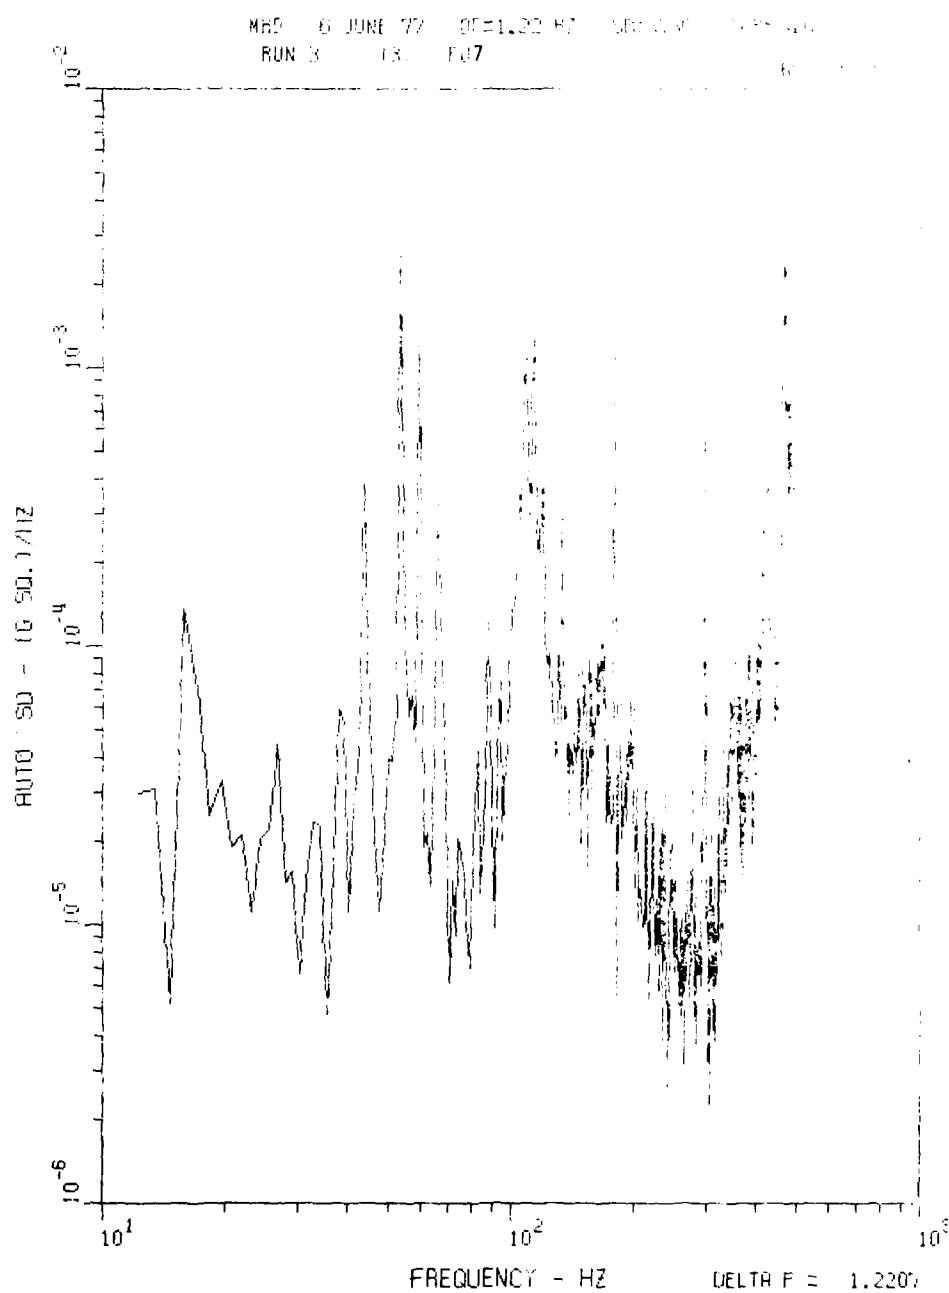
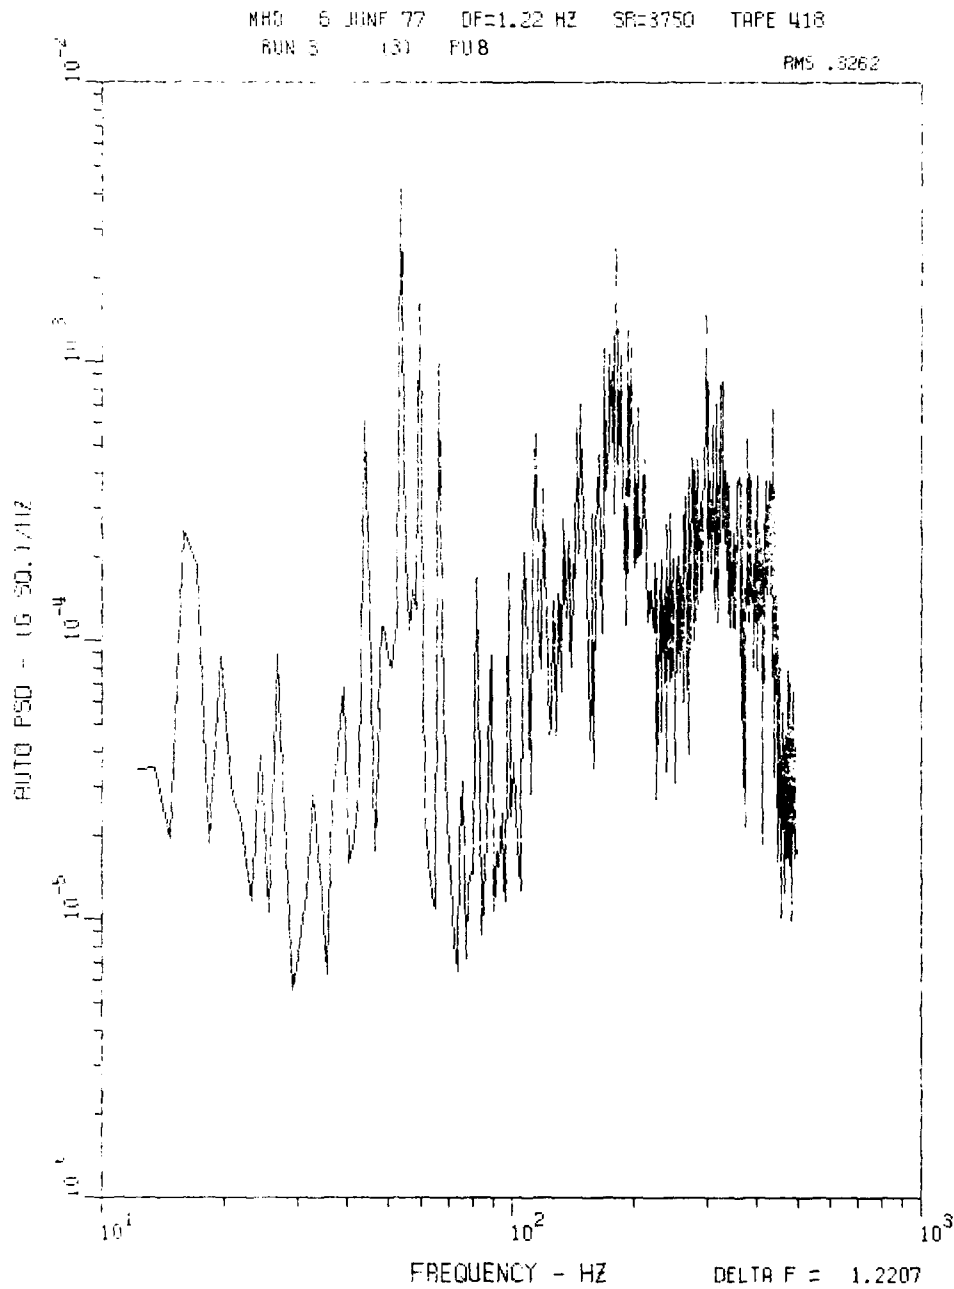
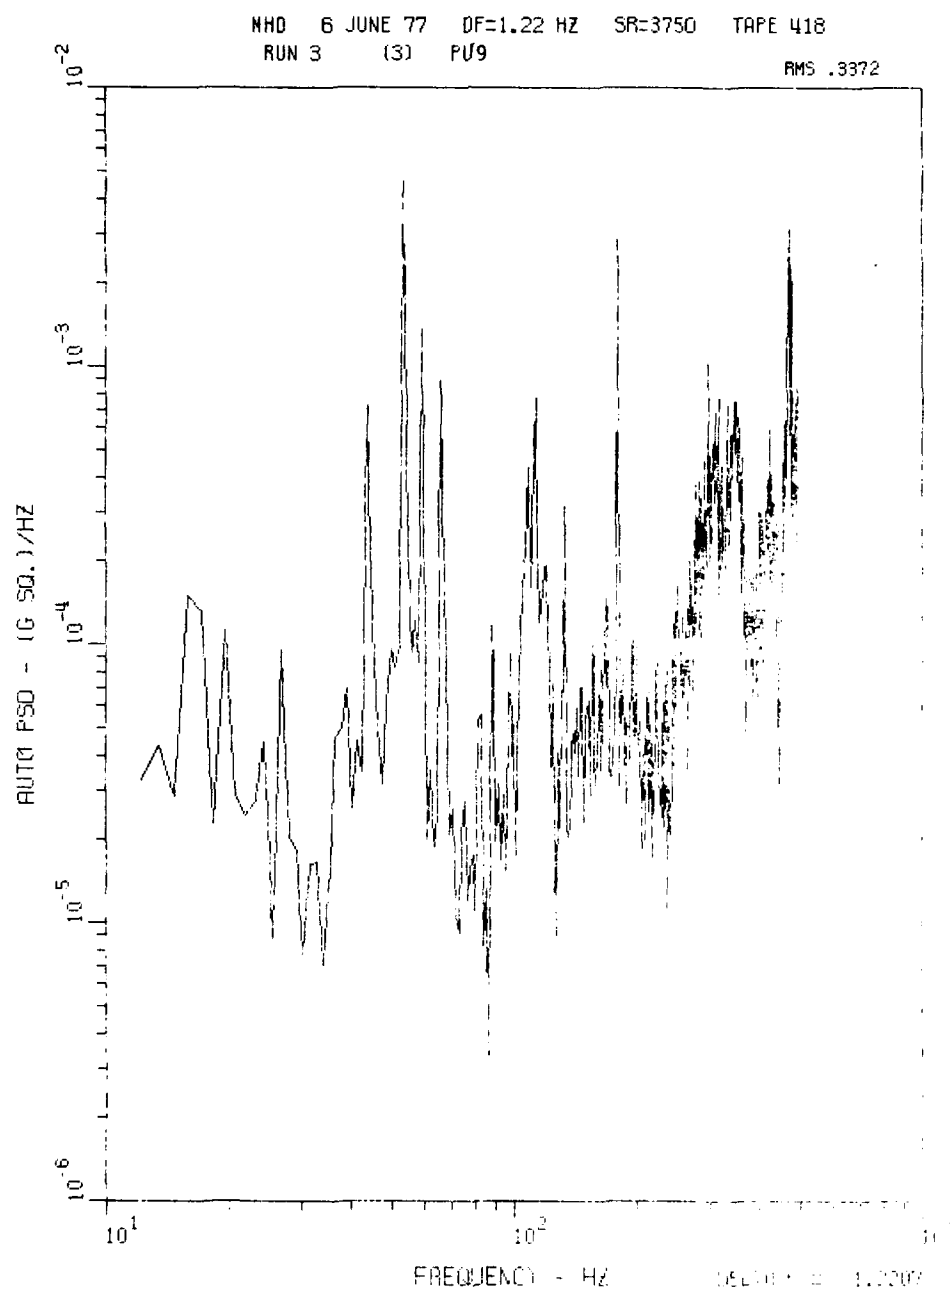
Figure 68. Accelerometer 3 PSD, 0-500 Hz, Run LWC 003

Figure 69. Channel Five PSD, 0-500 Hz, Run LWC 003

Figure 70. Channel Six PSD, 0-500 Hz, Run LWC 003

To show the lower frequency modes more clearly, accelerometer responses were analyzed from zero to 500 Hz. The results for run Number LWC 3 are shown in Figures 68-76, those for run number LWC 13 in Figures 77-86, and those for run Number LWC 23 in Figures 87-98. Accelerometers 1, 2, and 4 are missing from run LWC 3, and accelerometers 2 and 4 are missing from run LWC 13. For run LWC 23, accelerometers 2, 8, and 11 were replaced by accelerometers x, y, and z on the combustor flange.

These responses showed little indication of any change in damping with wear on the channel. Although the random character of the rocket exhaust excitation results in fluctuations in the relative amplitudes at different frequencies from run to run, distinct modes can be identified.

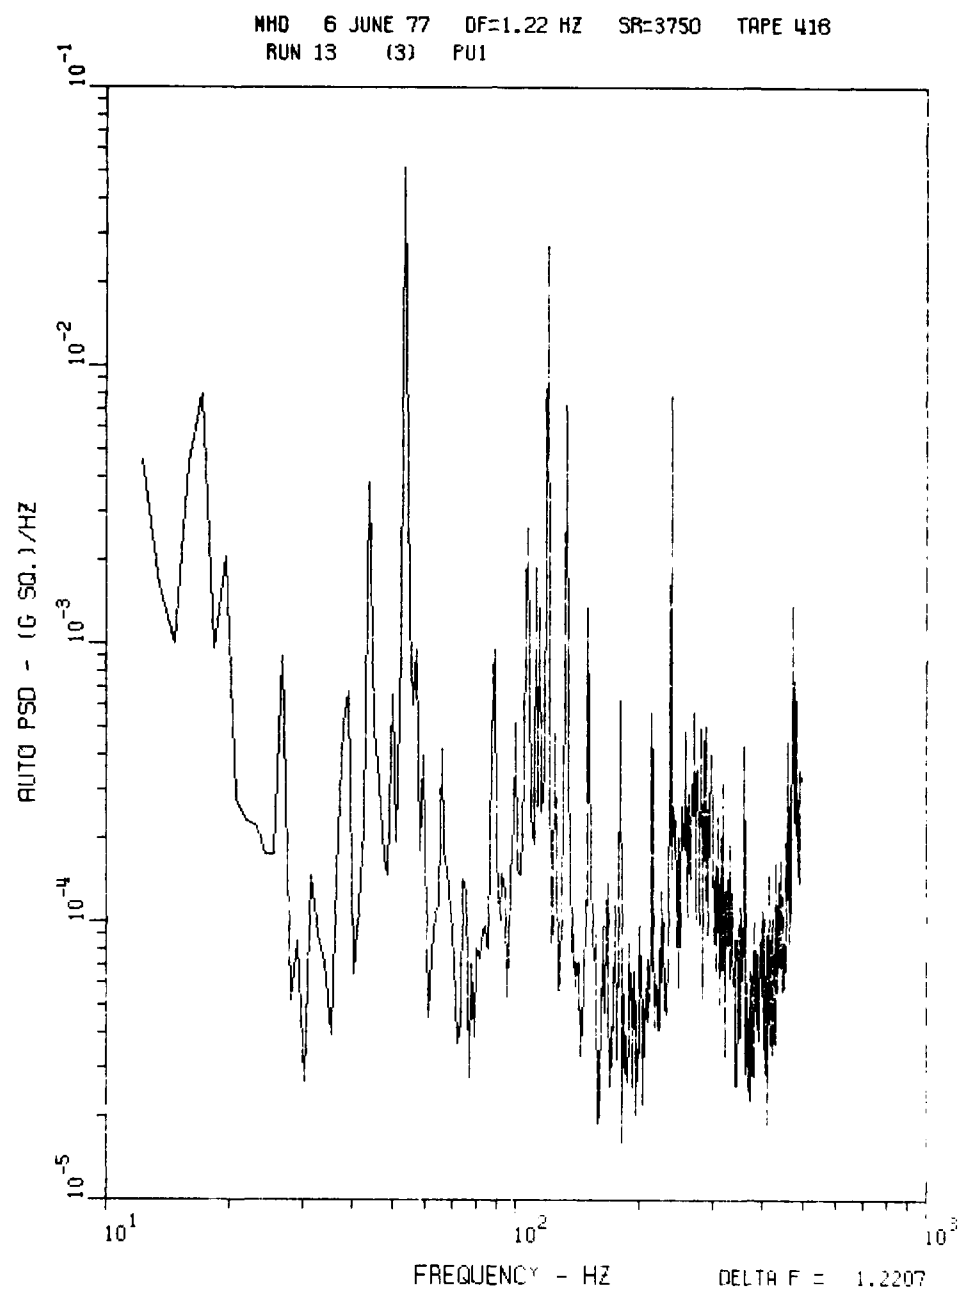
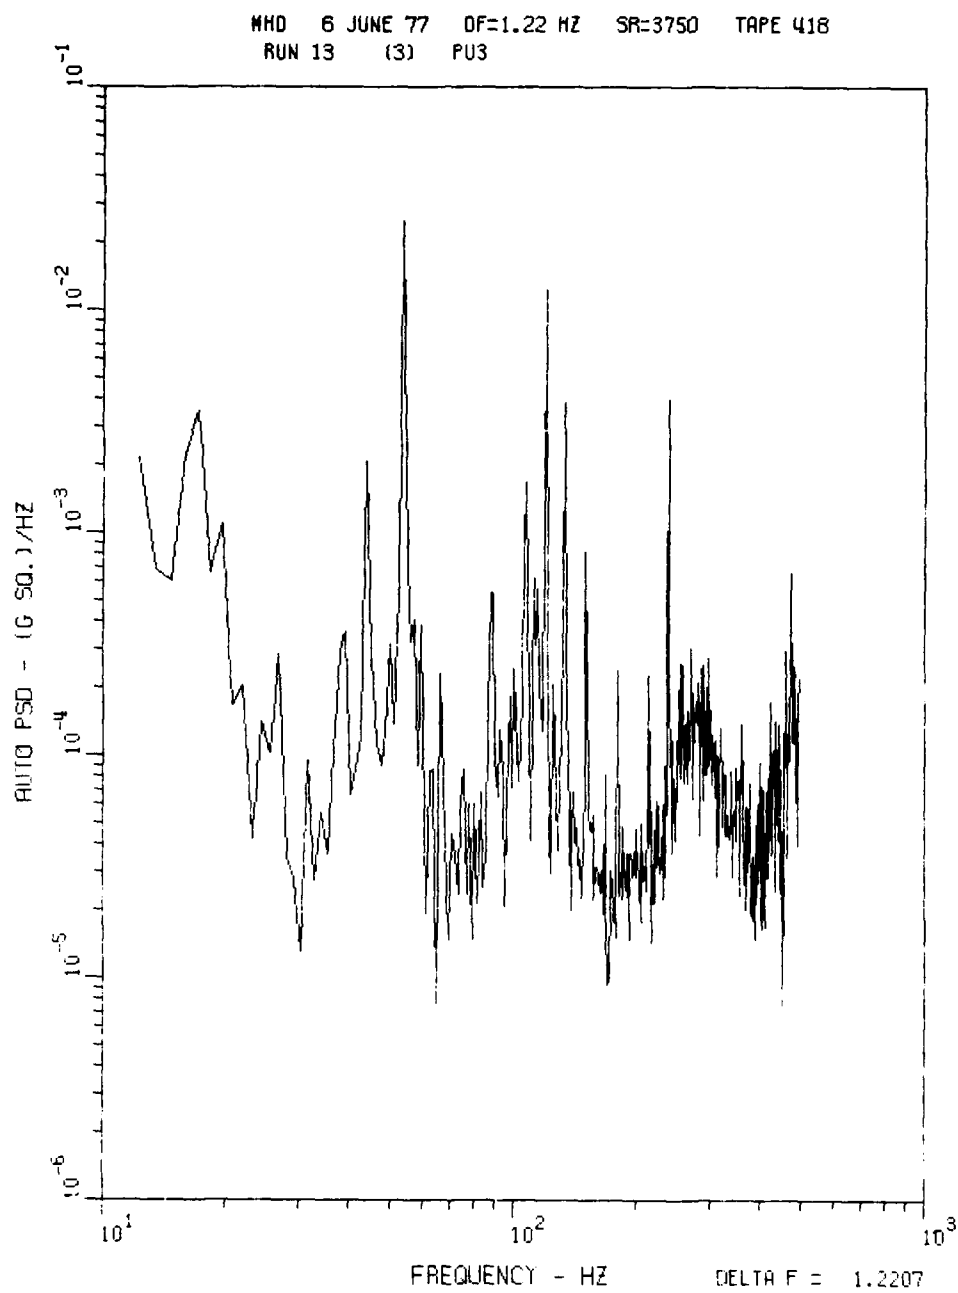
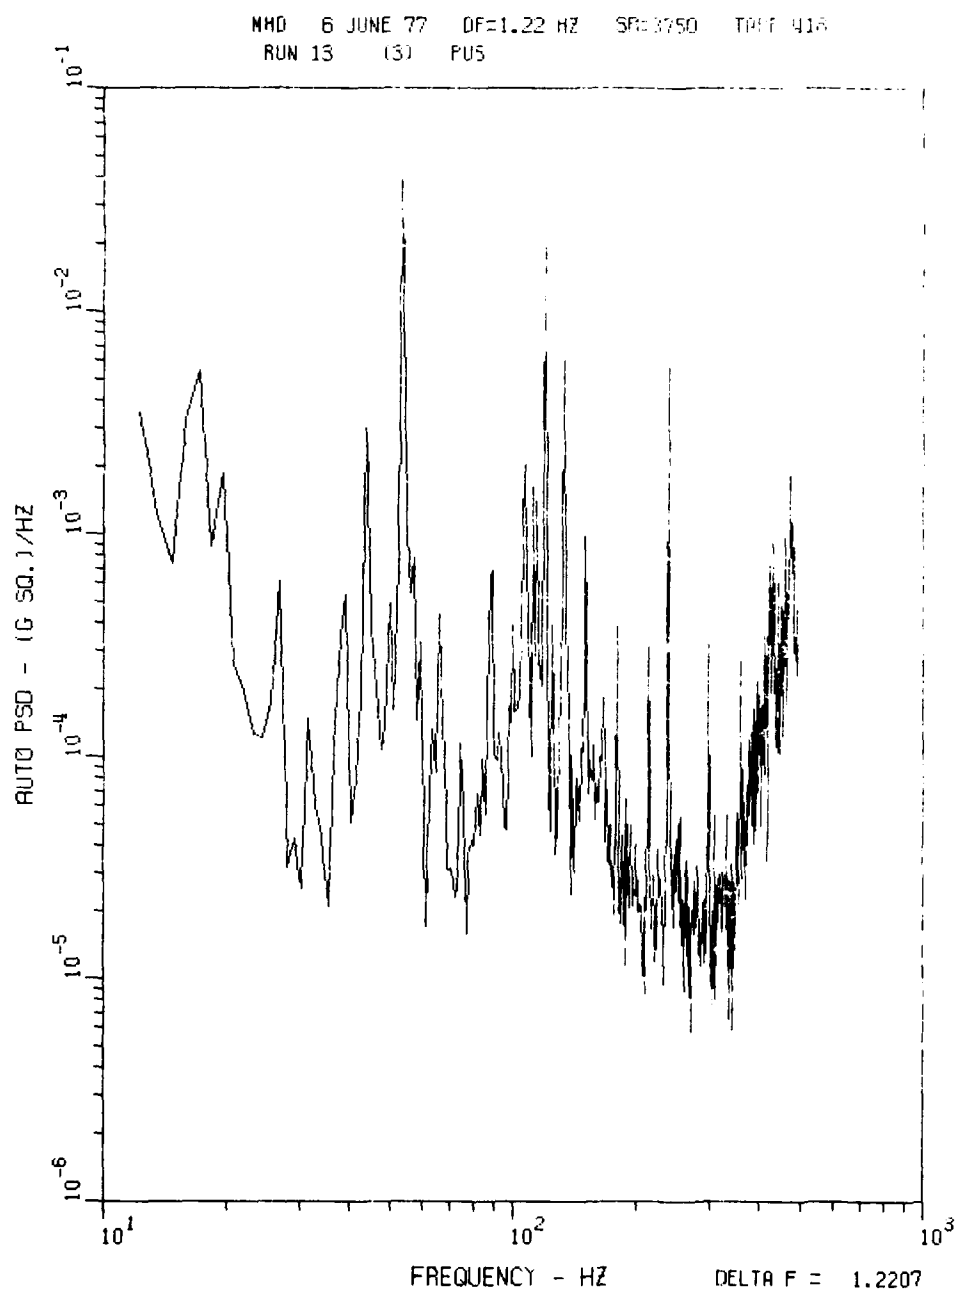
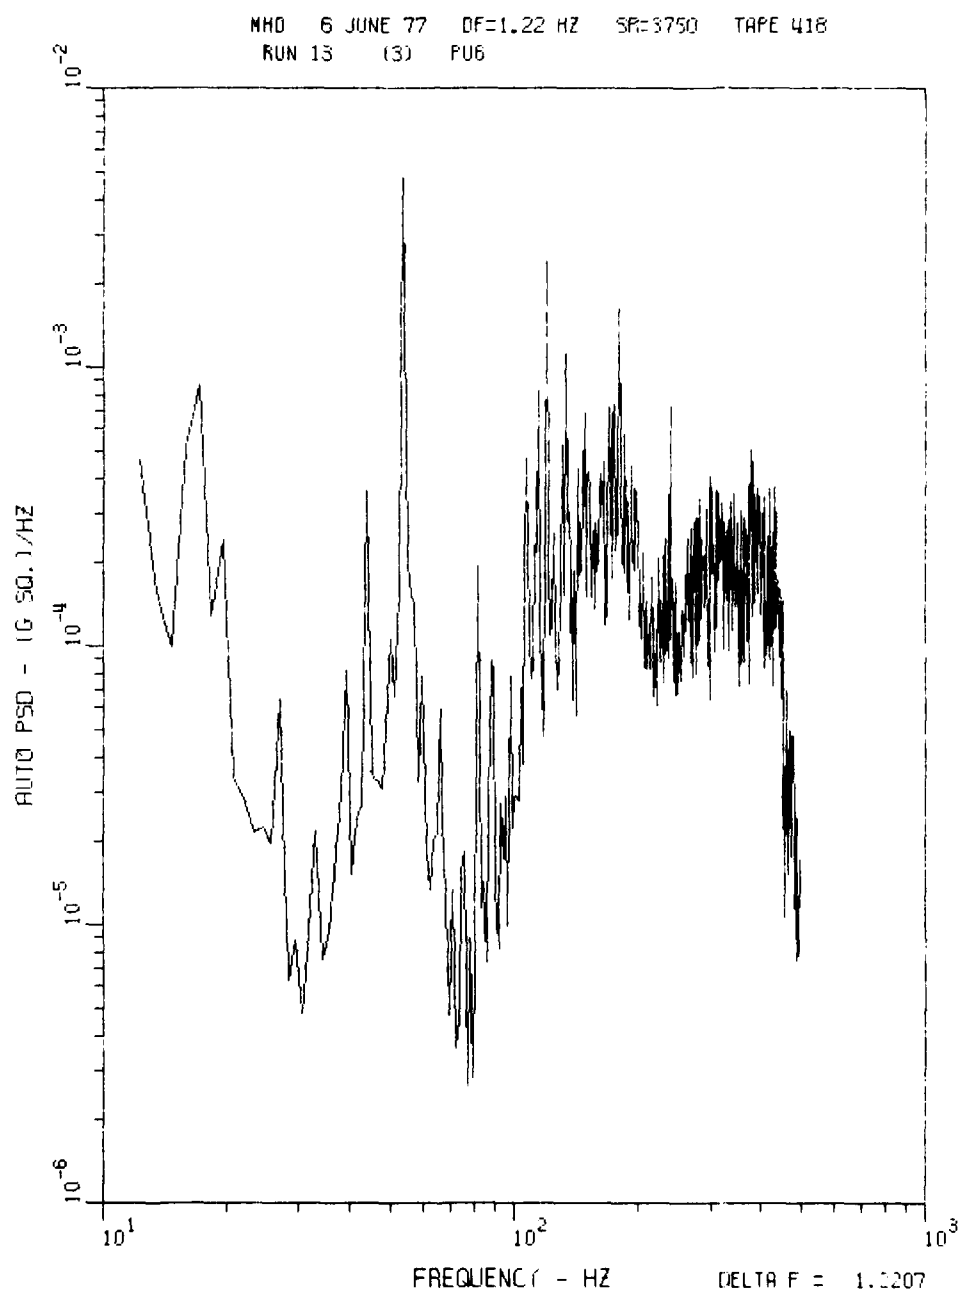
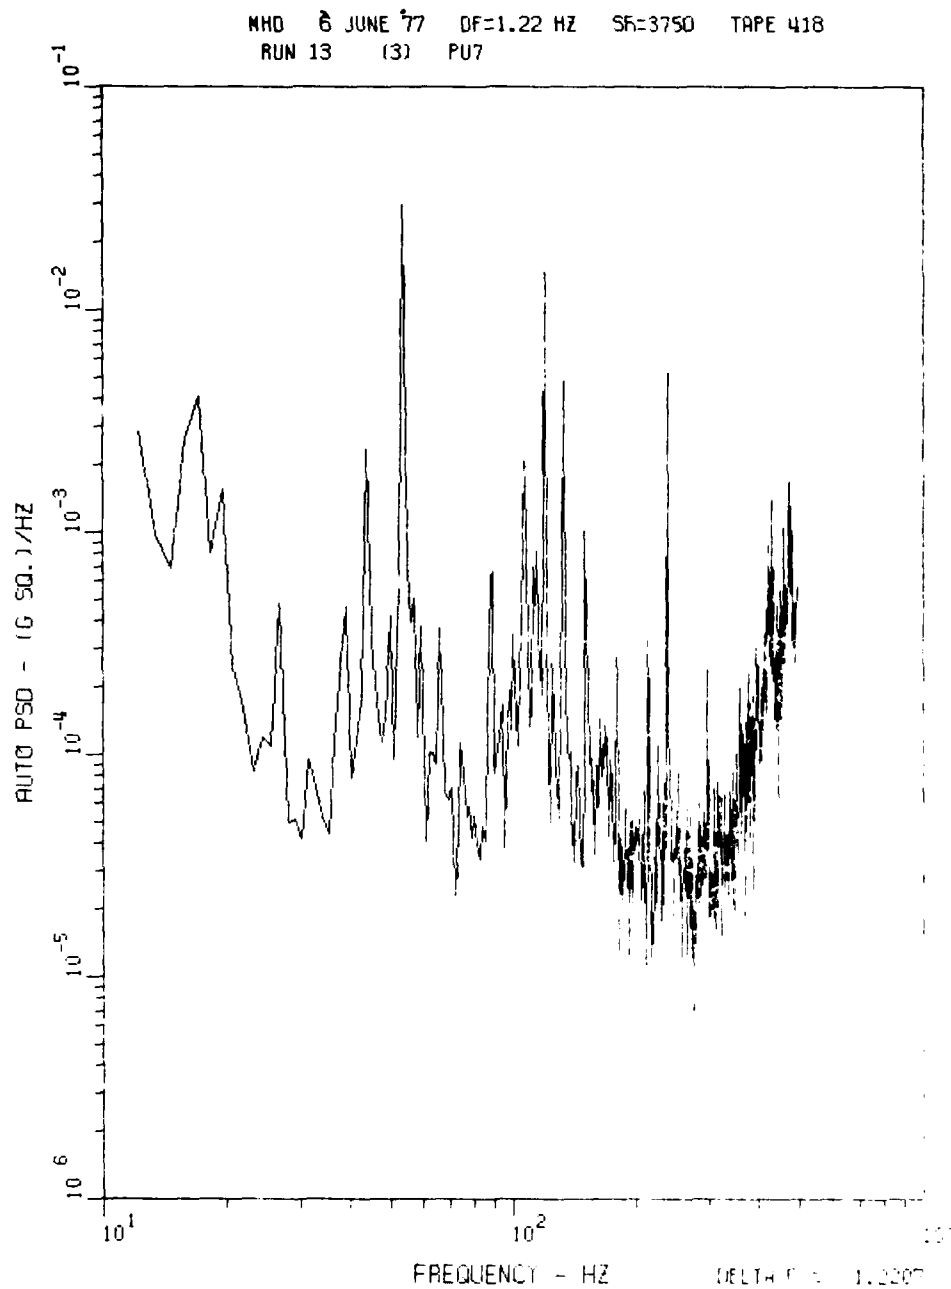
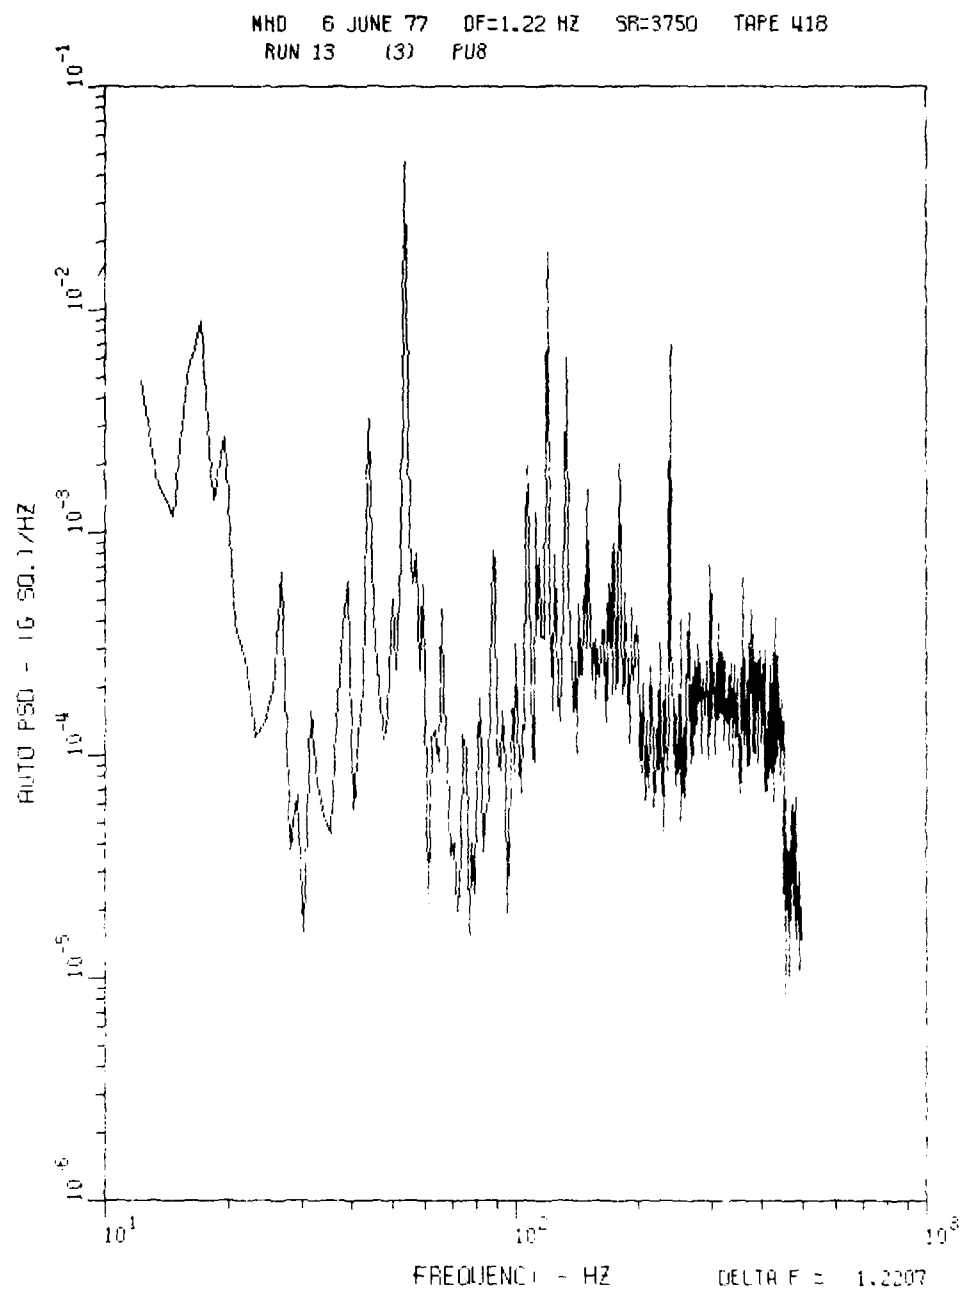
Figure 77. Channel One PSD, 0-500 Hz, Run LMC 013

Figure 78. Channel Three PSD, 0-500 Hz, Run LWC 013

Figure 79. Channel Five PSD, 0-500 Hz, Run LWC 013

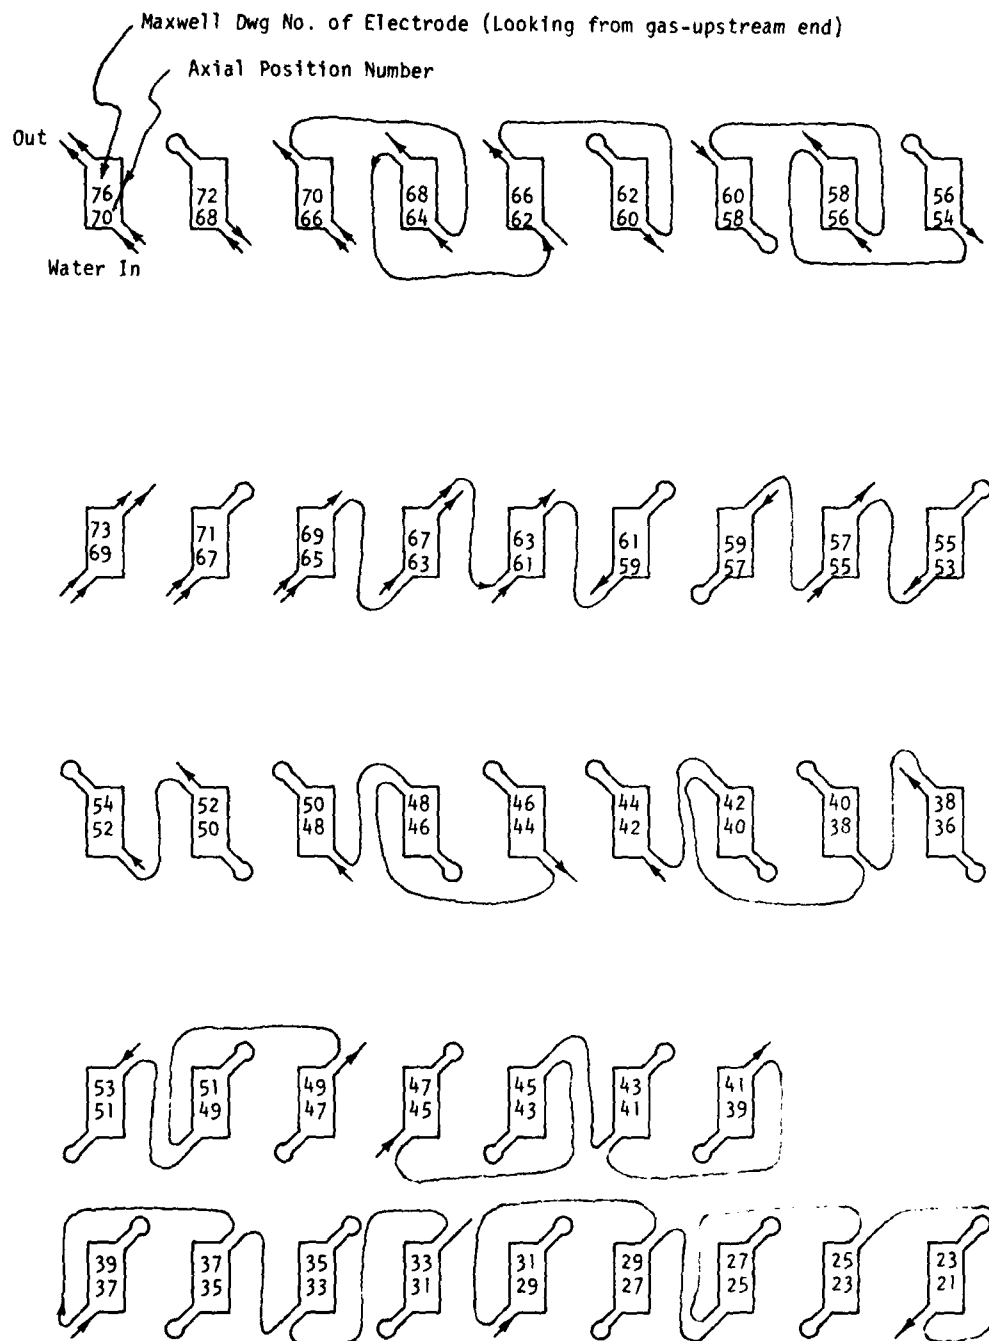
Figure 121. MHD Channel Electrode Water Circuit Schematic

NOTE: There are 70 Electrodes. Electrode Dwg. Nos. 75, 74, 65, 64 are not present. 31 Inlets; 31 Outlets. The top number in each frame is Maxwell Dwg No.; Bottom Number is Channel Axial Position Sequence.
